Contract #: 04-0120F4Cty: SF/ALA Rte: 80 PM: 13.2/13.9File #: 69.28**WELDING INSPECTION REPORT****Resident Engineer:**Pursell, Gary**Address:** 333 Burma Road**City:** Oakland, CA 94607**Report No:** WIR-000695**Date Inspected:** 12-Oct-2007**Project Name:** SAS Superstructure**OSM Arrival Time:** 630**Prime Contractor:** American Bridge/Fluor Enterprises, a JV**OSM Departure Time:** 1530**Contractor:** Zhenhua Port Machinery Company, Ltd (ZPMC), Changxing Island **Location:** Shanghai, China**CWI Name:** Xu Jun**CWI Present:** Yes No**Inspected CWI report:** Yes No N/A**Rod Oven in Use:** Yes No N/A**Electrode to specification:** Yes No N/A**Weld Procedures Followed:** Yes No N/A**Qualified Welders:** Yes No N/A**Verified Joint Fit-up:** Yes No N/A**Approved Drawings:** Yes No N/A**Approved WPS:** Yes No N/A**Delayed / Cancelled:** Yes No N/A**Bridge No:** 34-0006**Component:** Tower Mock-up 89 M and OBG weld trial**Summary of Items Observed:**

**Tower Mock-up 89 Meter Elevation**

1	OBG Weld Trial			
---	----------------	--	--	--

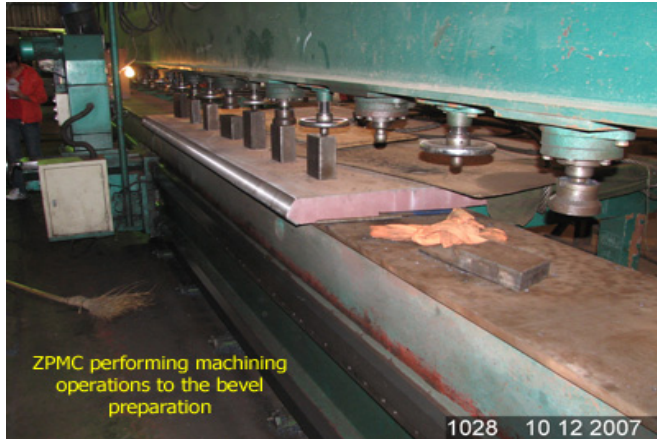
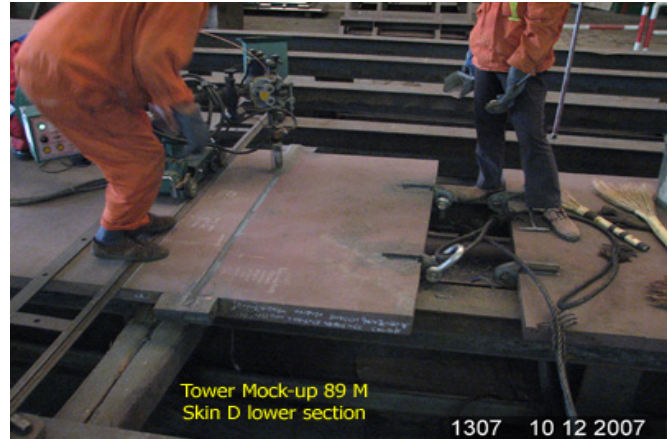
In cursory visit to the Tower Mock-up shop the QA inspector observed ZPMC performing welding operations on the skin D lower section at the junction of the plate mp506 to the MA22 with the submerged arc welding (SAW) process. Also, The QA inspector observed that ZPMC performing machining operations at the bevel from the skin plates. See digital photograph below.

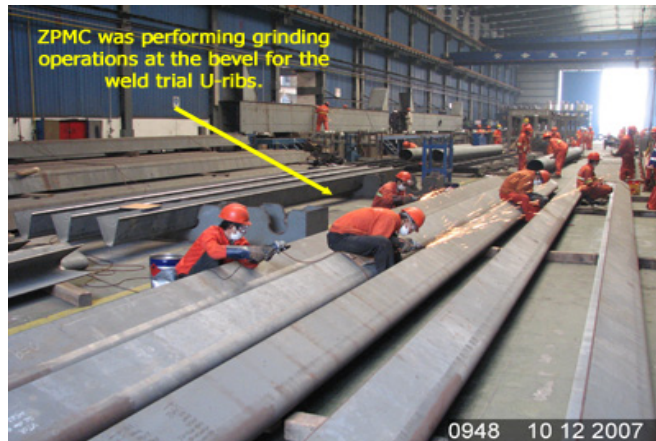
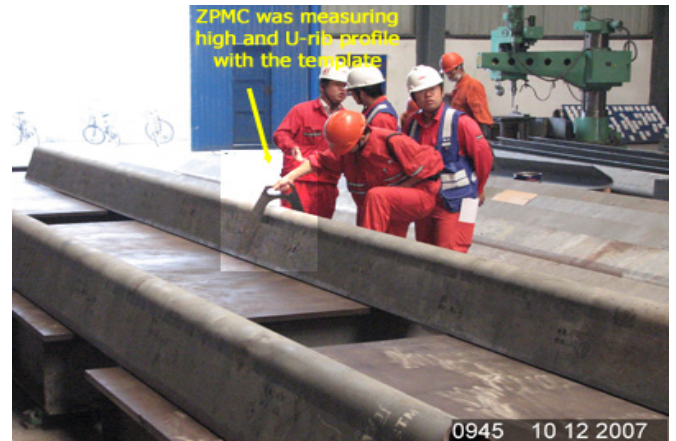
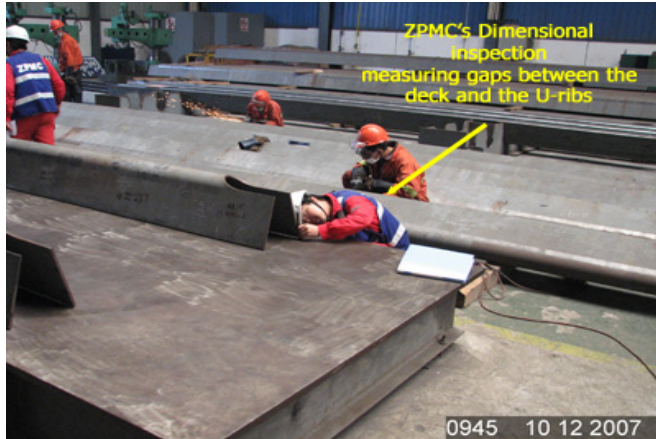
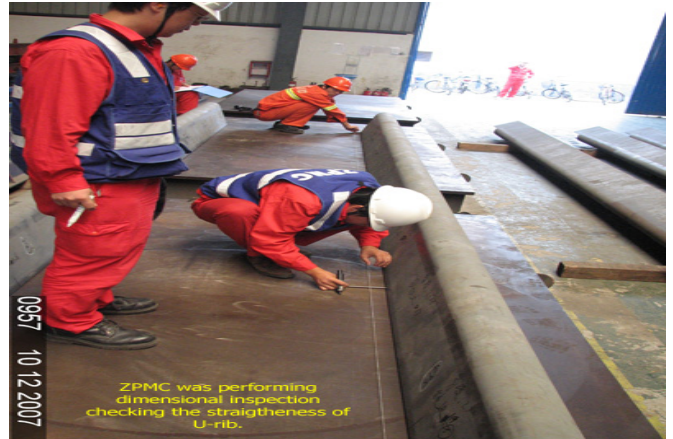
The QA inspector observed that ZPMC was performing grinding operations at the U-ribs designated as U-95, U-6, U-21, U-41 and U-3. The QA performed dimensional inspections to the root face, bevel angle and total length to the above mentioned U-ribs. The QA inspector witnessed ZPMC performing flatness, straightening, high and U-rib profile verifications on the U rib U-21.

The digital photographs below show ZPMC grinding the U ribs bevel preparations and performing dimensional verifications
